LAWRENCE
LIVERMORE
NATIONAL
LABORATORY

LLNL-TR-648143

A Visual Description of the Concrete Exterior of the Cactus Crater Containment Structure

October 2013

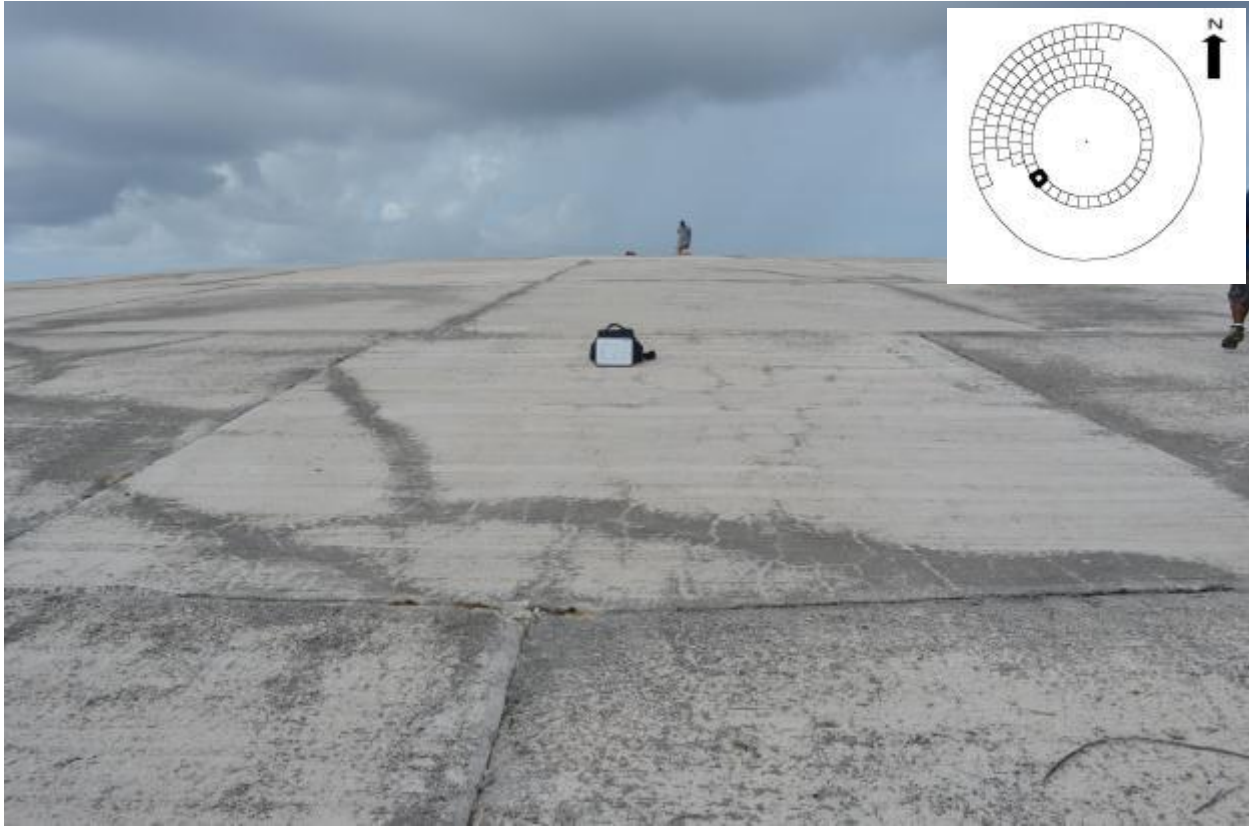
CAP SECTION LOCATION: Panel E26

Some spalling/cracking of concrete observed on the left-hand side of the lower seam. Surface cracks observed in the lower left-hand corner of the panel. Additional minor cracks have formed up and across the panel, the most significant of which intersects the left side seam about 2 meters from the top of the panel. Rooting vegetation removed from along the panel seams.

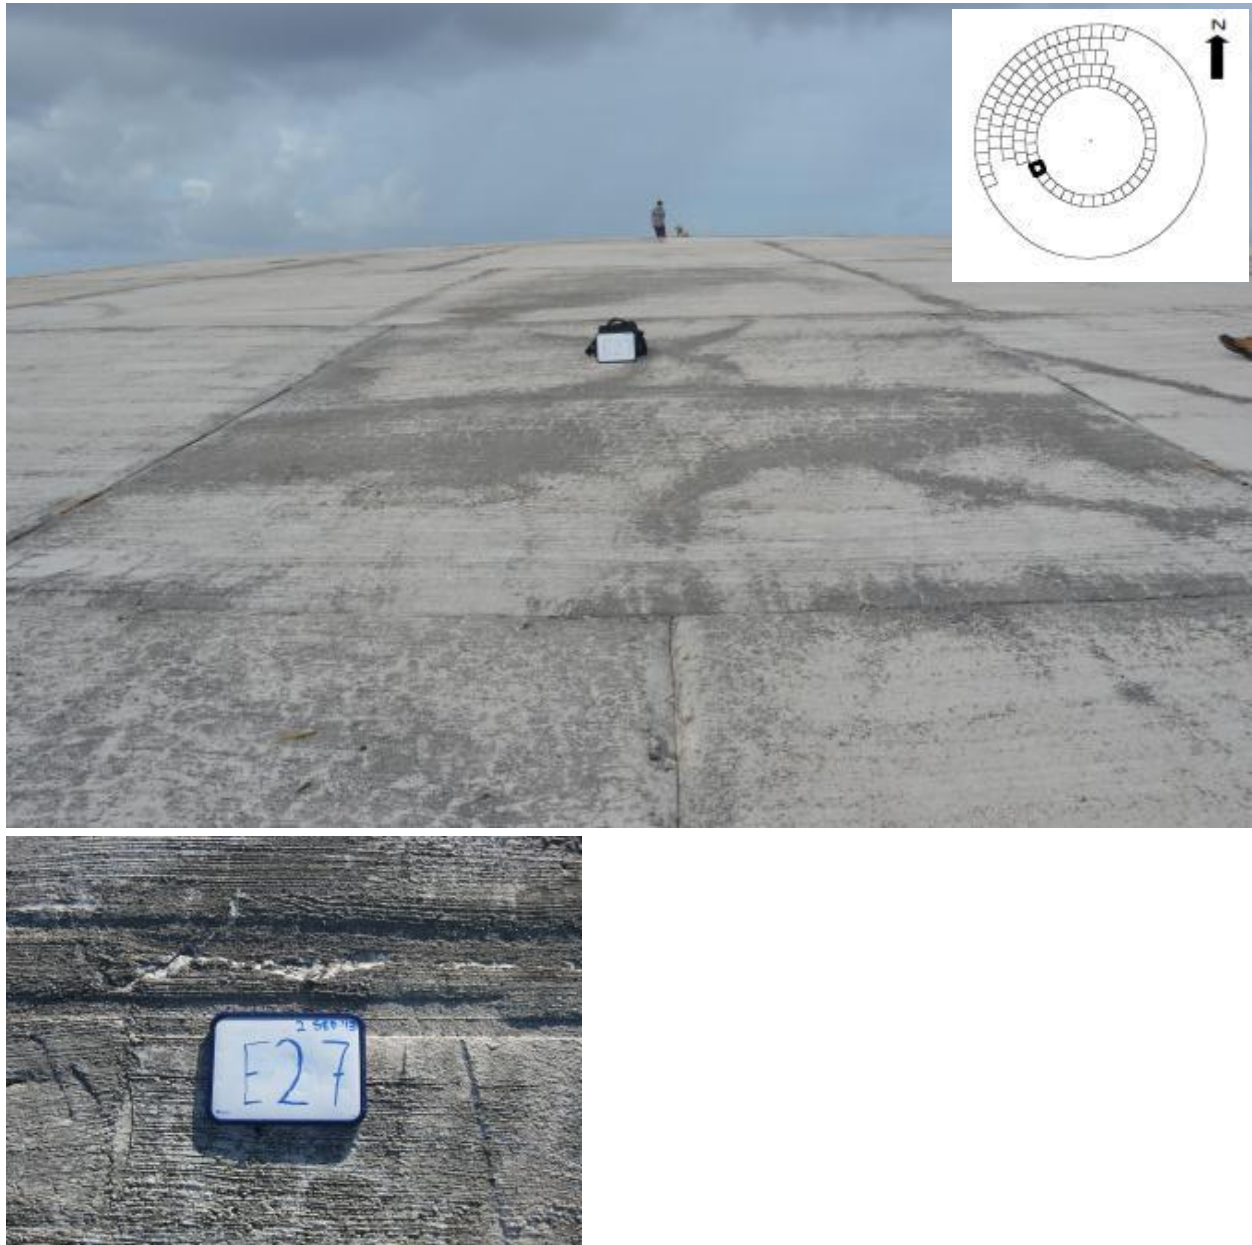
CAP SECTION LOCATION: Panel E27

Panel has a rough and weathered appearance. The main observable feature is a surface crack running left to right at a mid-point up the panel. Cracks have chipped “spalled” edges. Other very minor cracks observed forming a crisscrossing pattern around the panel. Rooting vegetation removed from along the panel seams.

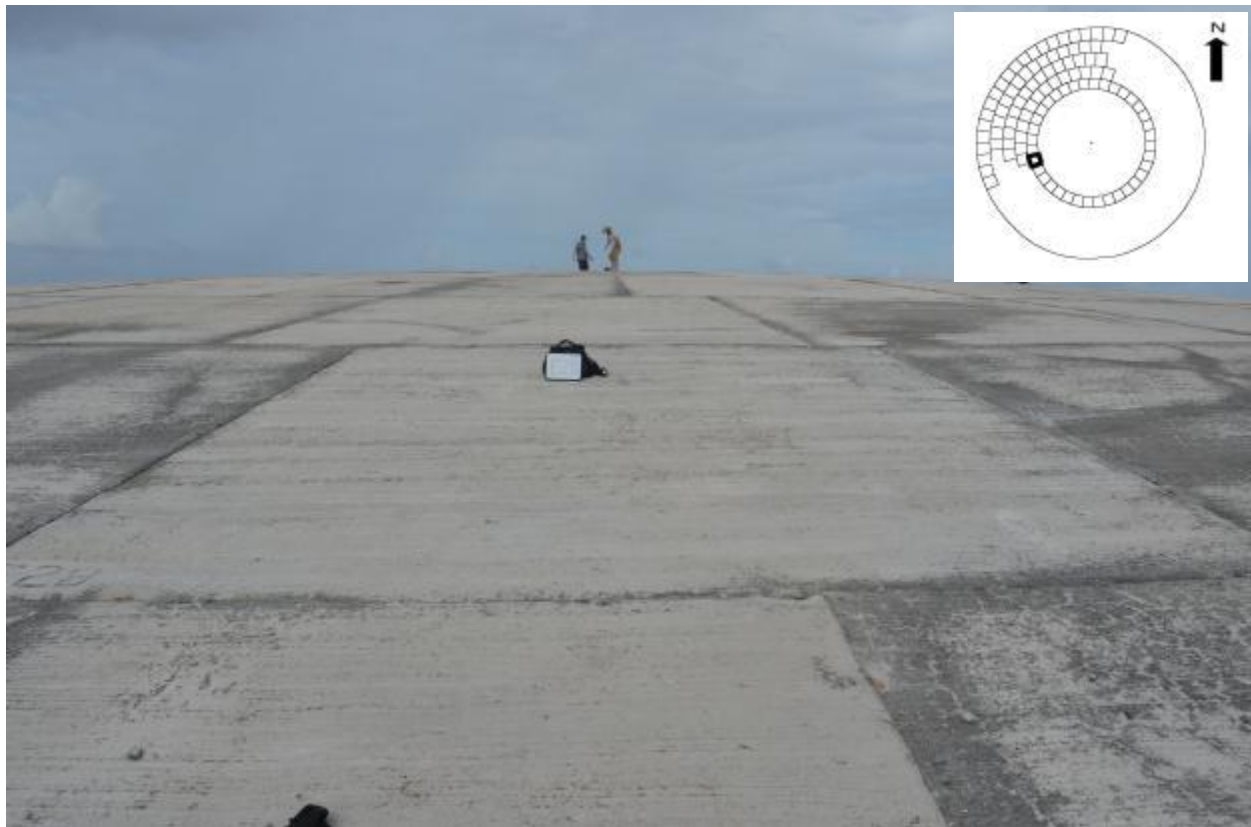
CAP SECTION LOCATION: Panel E28

No significant or obvious interior cracks extending across the top of the panel. The panel has a rough and weathered appearance. Rooting vegetation removed from along the panel seams.

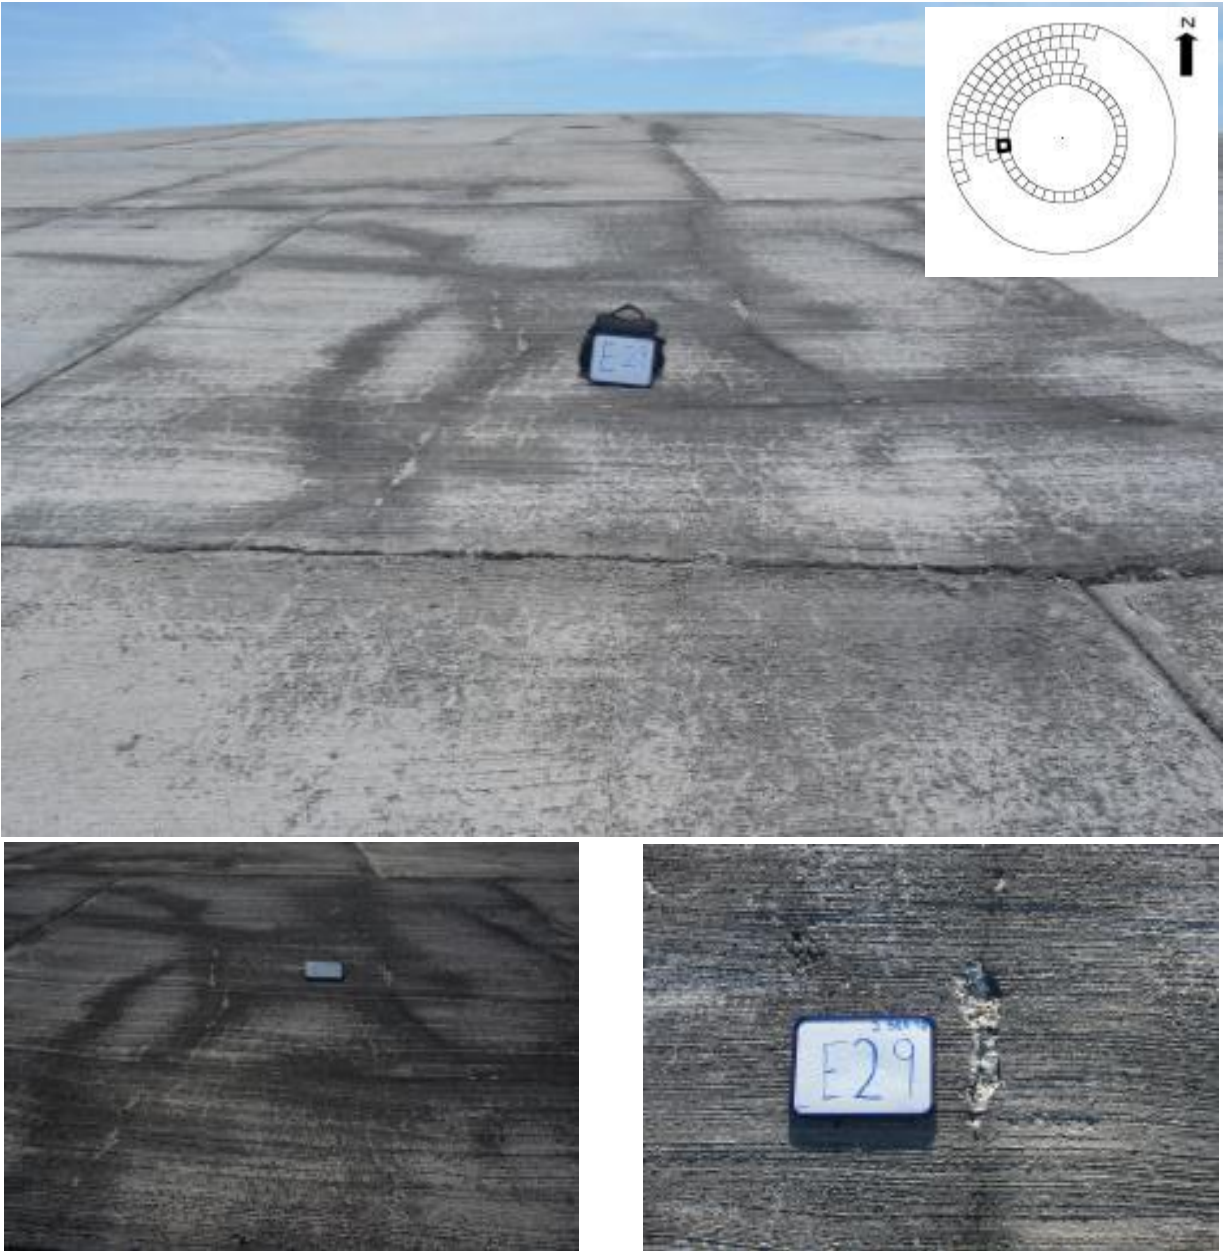
CAP SECTION LOCATION: Panel E29

There are numerous cracks with chipped “spalled” edges crisscrossing up and across the panel. Some spalling/cracking of concrete observed in the right-hand corner of the panel.

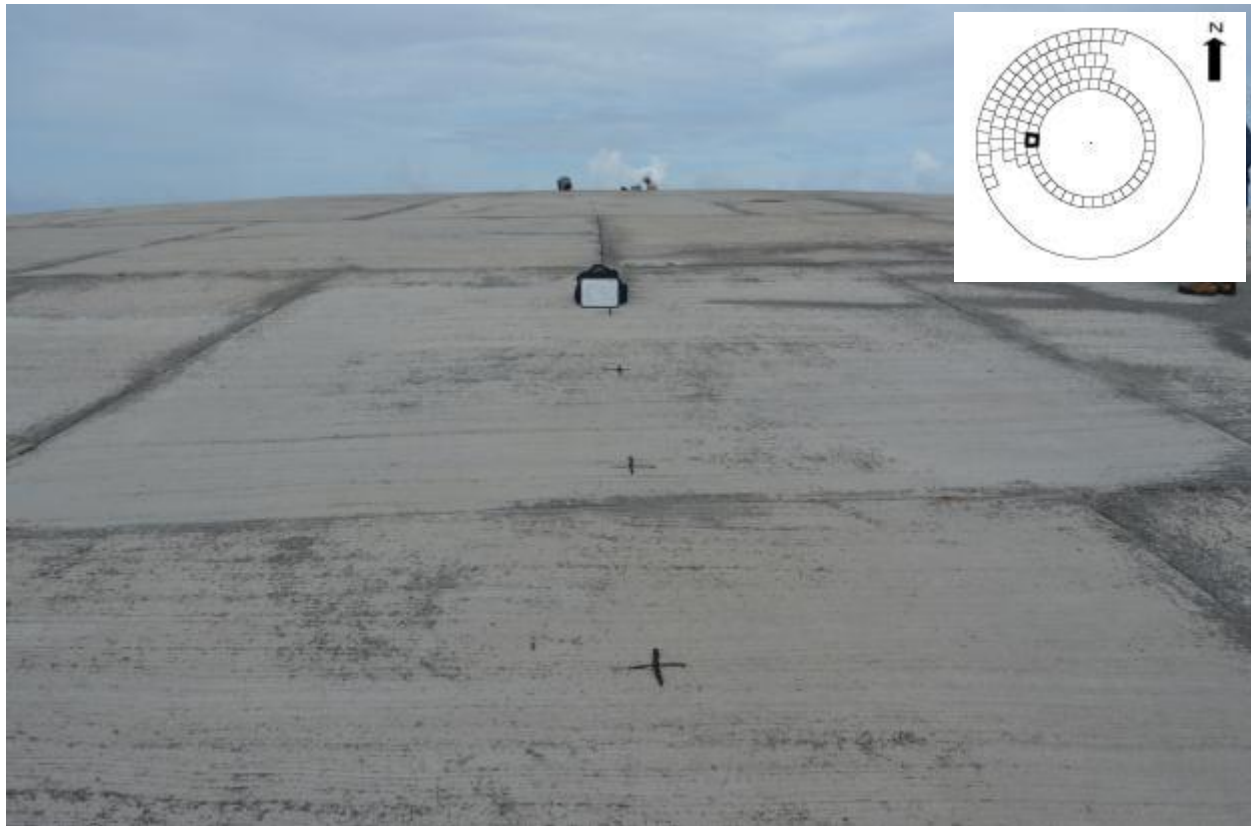
CAP SECTION LOCATION: Panel E30

No significant or obvious interior cracks extending across the top of the panel. Panel has a rough and weathered appearance. Rooting vegetation removed from along the panel seams.

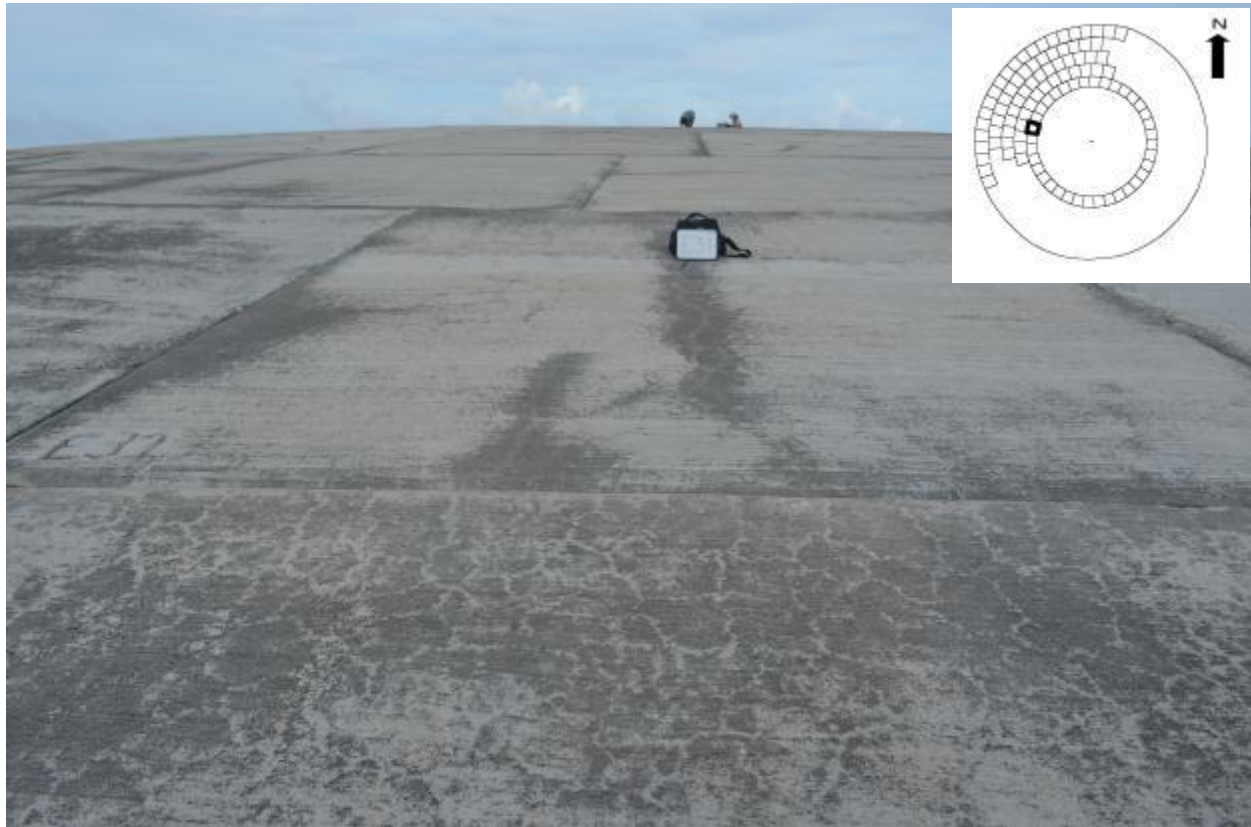
CAP SECTION LOCATION: Panel E31

No significant or obvious interior cracks extending across the top of the panel. The upper portion of the panel has a rough and weathered appearance. Rooting vegetation removed from along the panel seams.

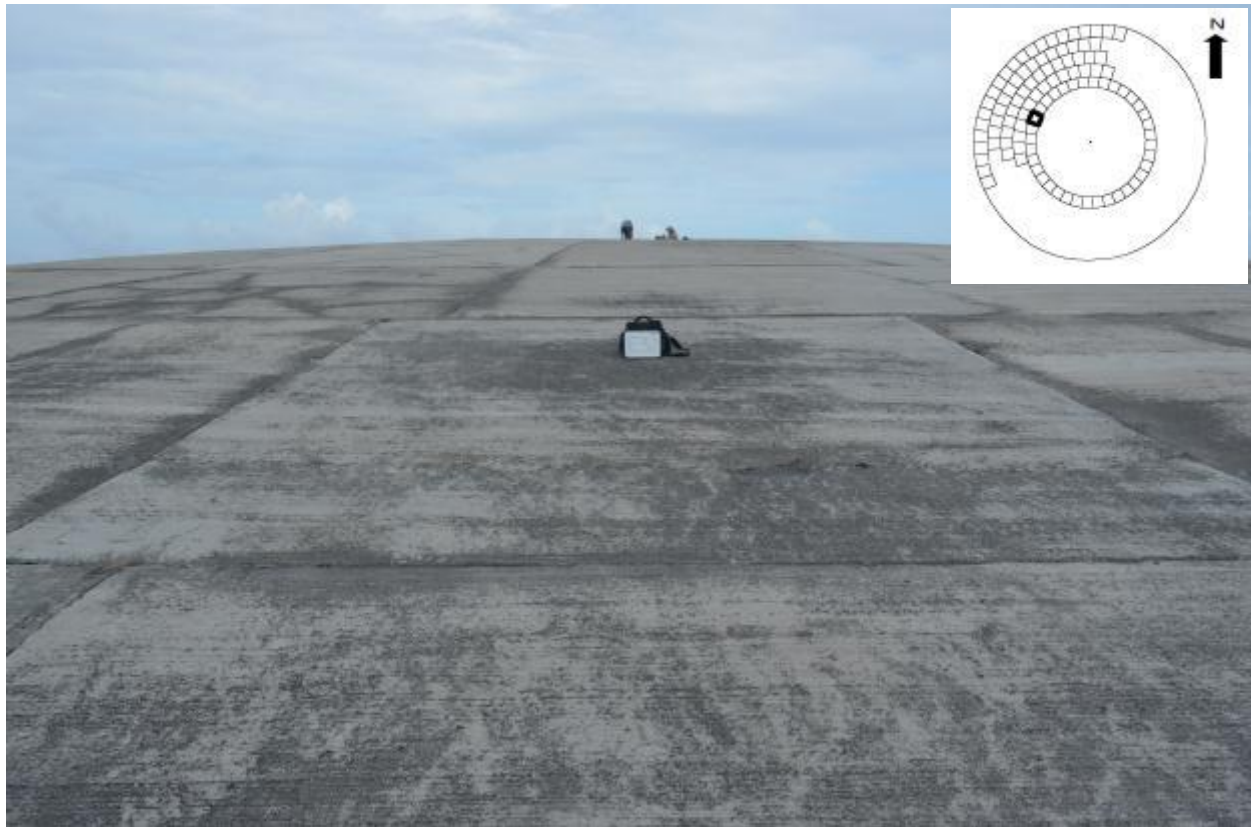
CAP SECTION LOCATION: Panel E32

No significant or obvious interior cracks extending across the top of the panel. Panel has a rough and weathered appearance. Rooting vegetation removed from along the panel seams.

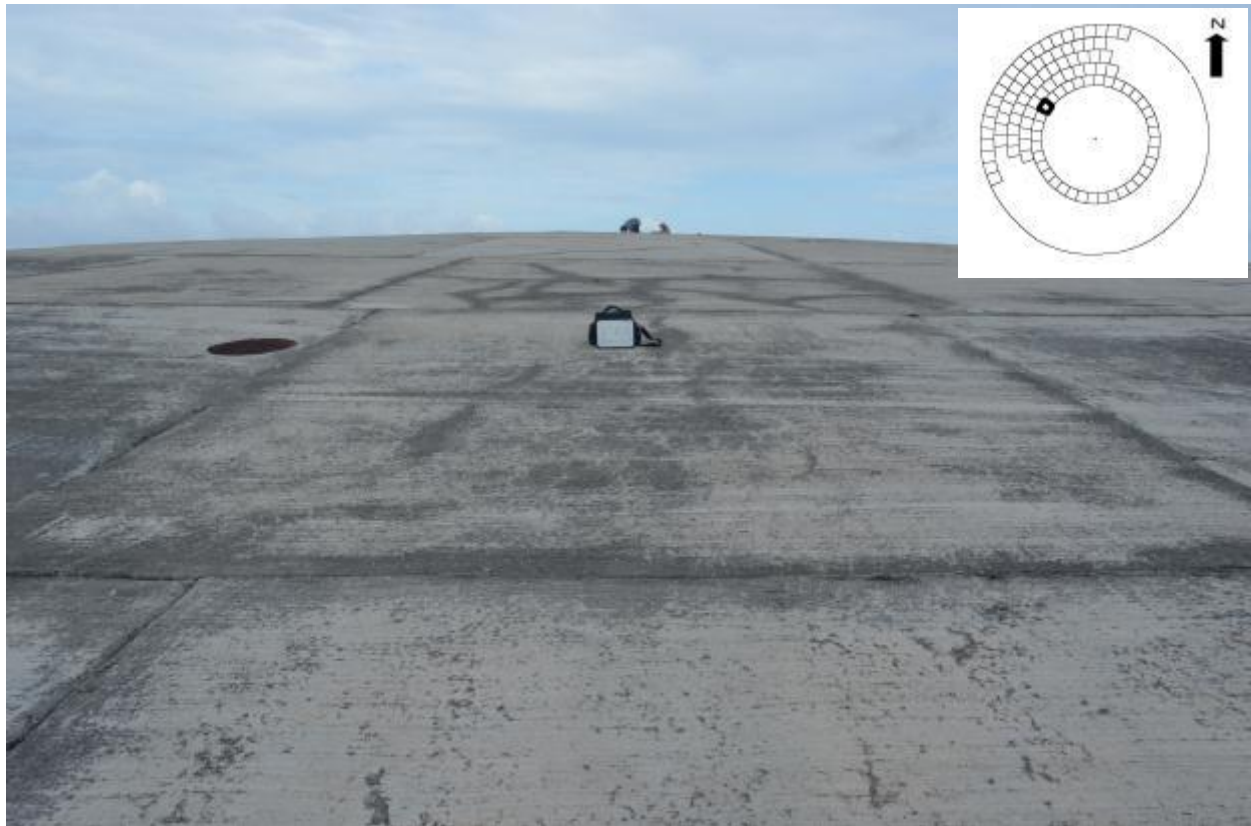
CAP SECTION LOCATION: Panel E33

No significant or obvious interior cracks extending across the top of the panel. The panel has a rough and weathered appearance.

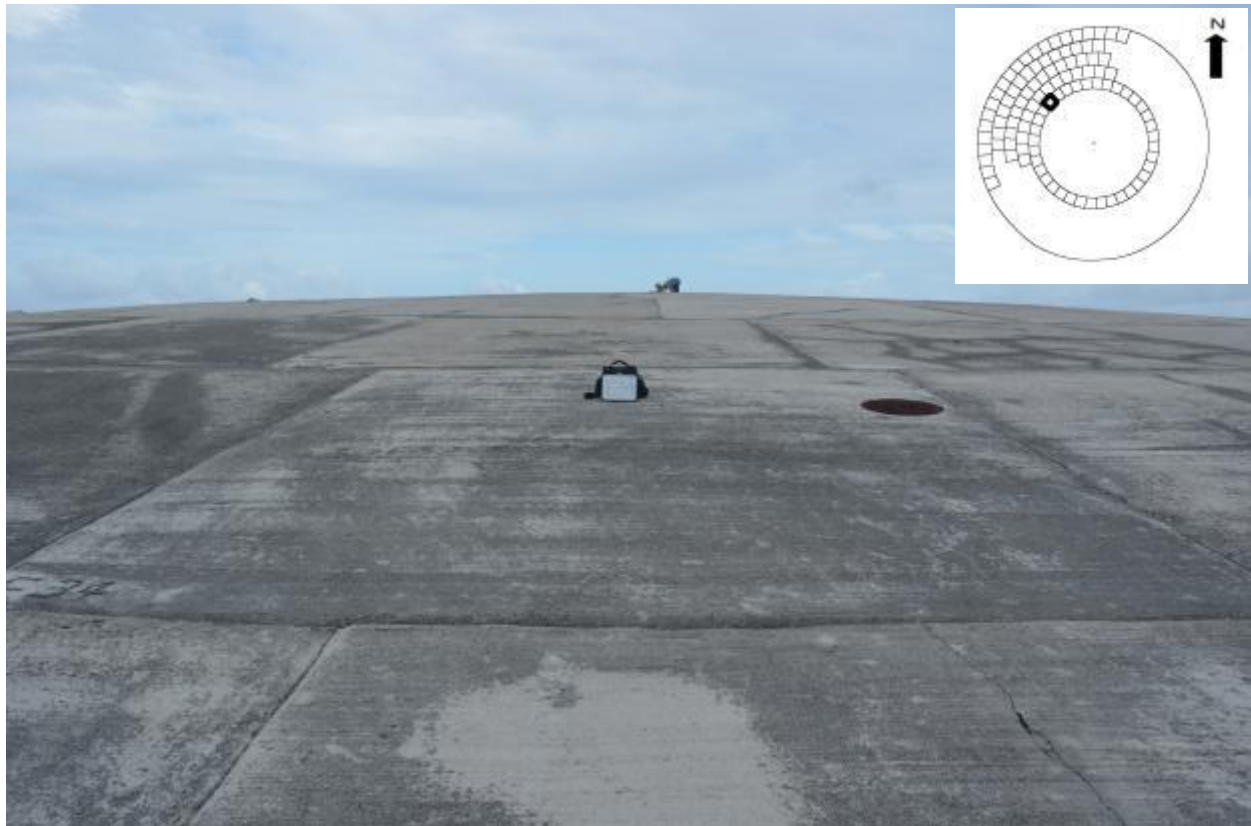
CAP SECTION LOCATION: Panel E34

No significant or obvious interior cracks extending across the top of the panel. The panel has a rough and weathered appearance. Panel contains a vertical elevation benchmark.

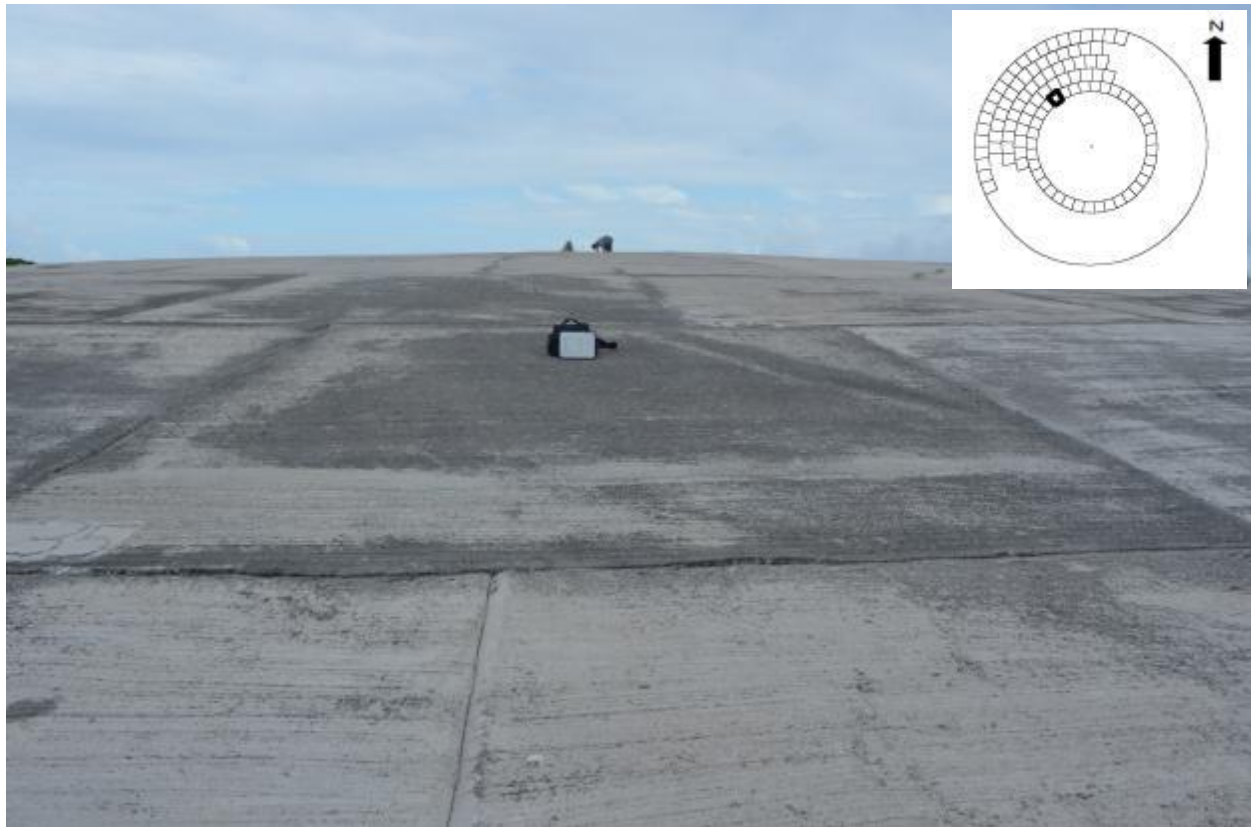
CAP SECTION LOCATION: Panel E35

No significant or obvious interior cracks extending across the top of the panel. The panel has a rough and weathered appearance.

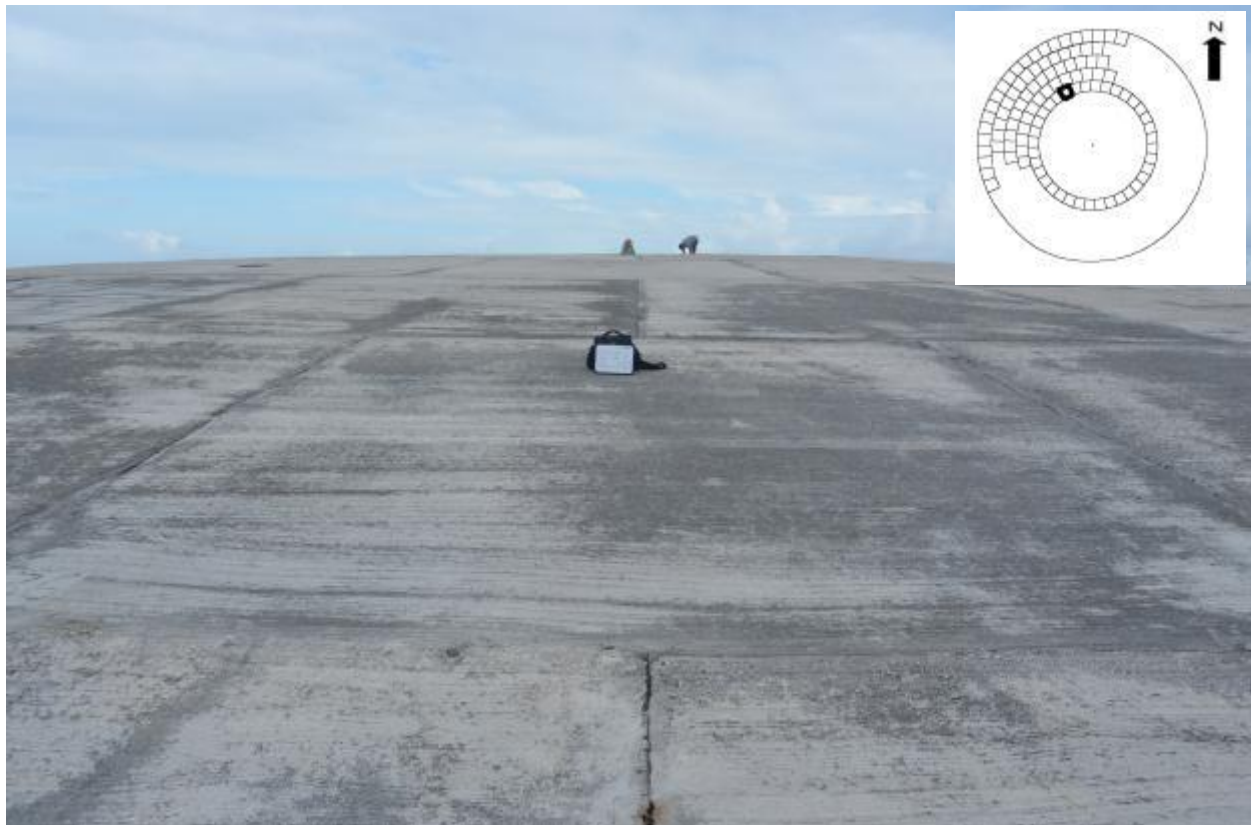
CAP SECTION LOCATION: Panel E36

The panel has a rough and weathered appearance. Some spalling/cracking of concrete observed along the upper and lower right seams, and in the upper right-hand corner, of the panel.

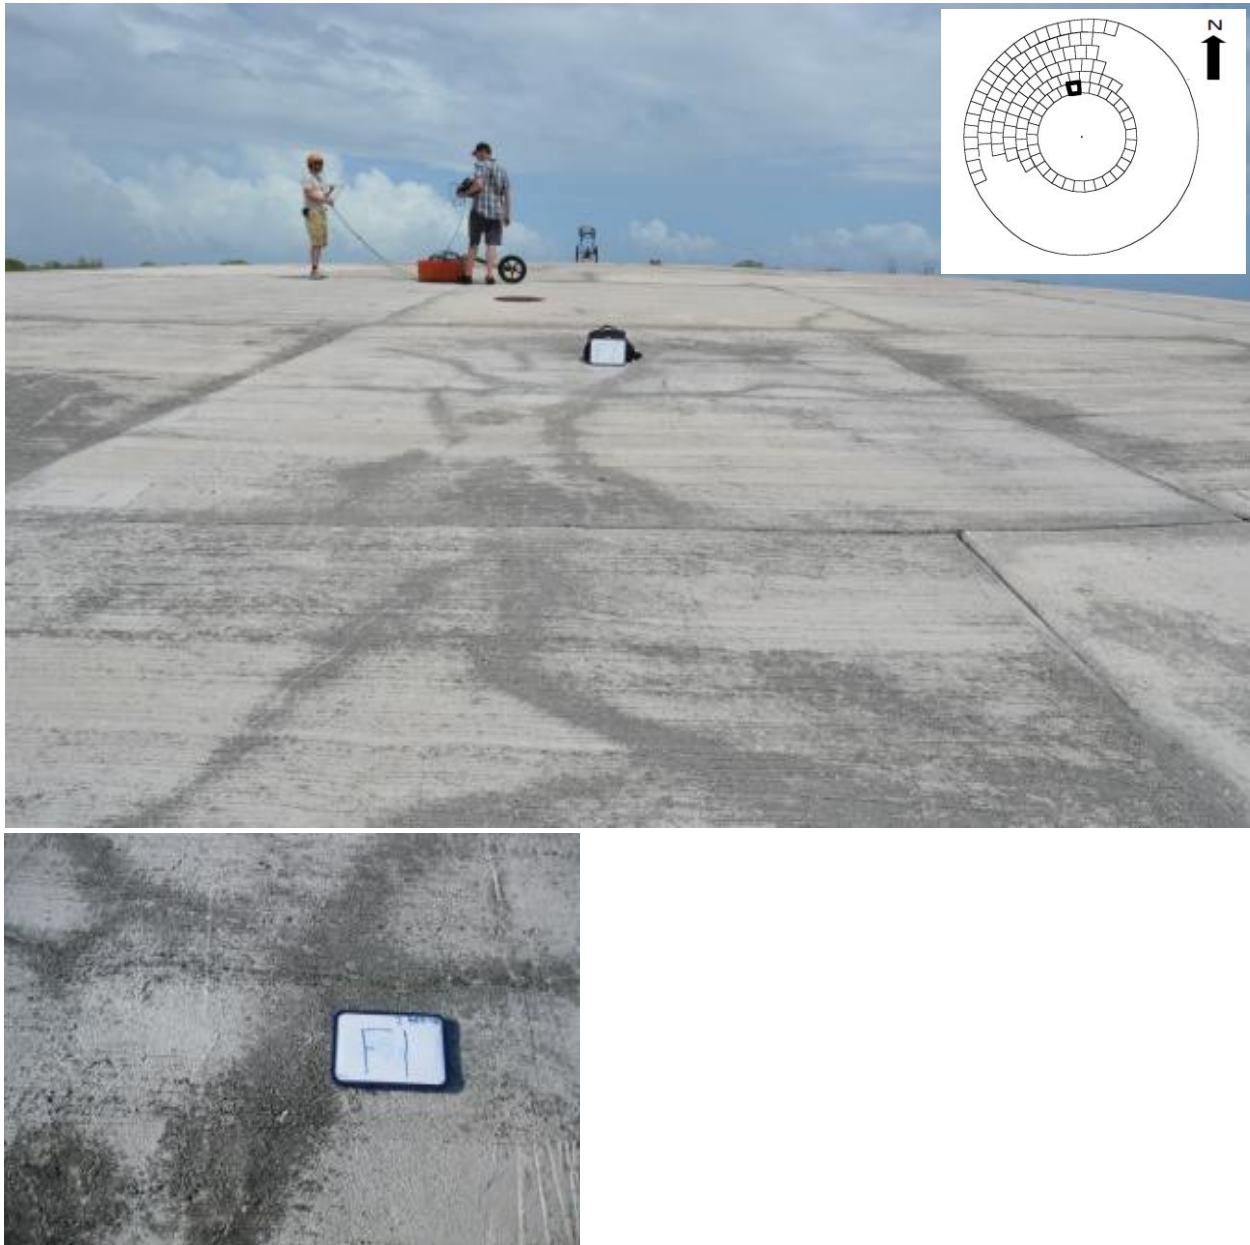
CAP SECTION LOCATION: Panel F1

Some spalling/cracking of concrete observed in the upper left-hand corner of the panel. Minor surface cracks extending up from the bottom seam in a crisscross pattern, and intersecting with the upper and left seams of the panel.

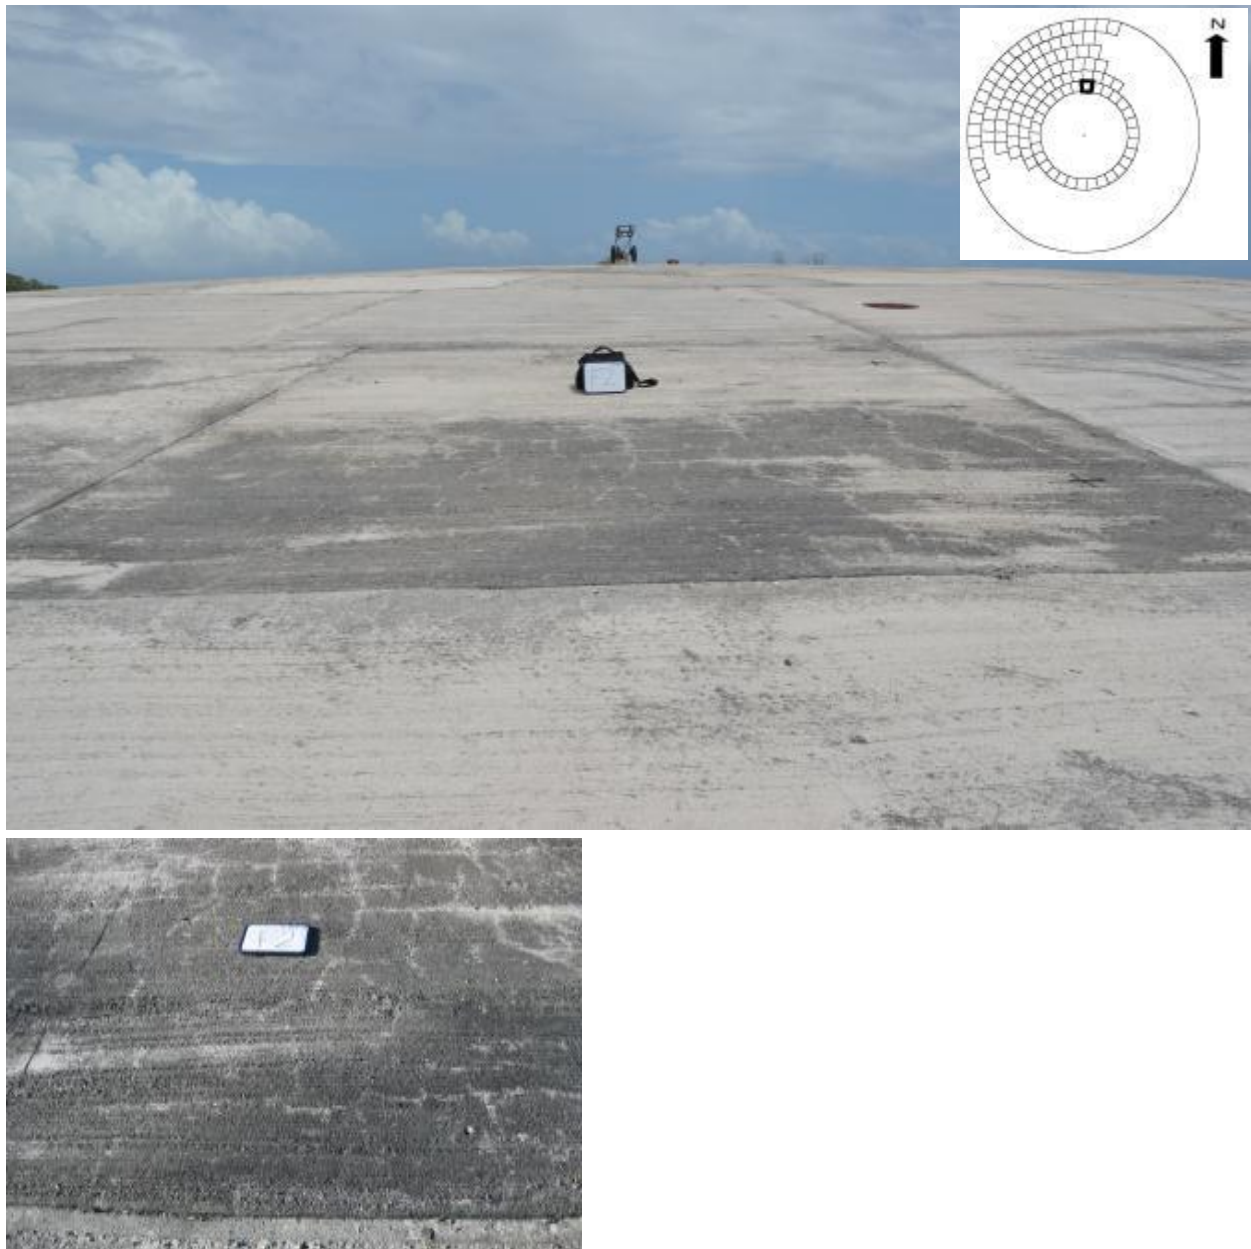
CAP SECTION LOCATION: Panel F2

The panel contains patches of discolored concrete. Some spalling/cracking of concrete observed in the upper left and right-hand corners of the panel. No significant or obvious interior cracks or spalls extending across the top of the panel with exception of numerous very minor cracks. Also, there is a small void in the concrete appearing near the upper left-hand corner (app. 4 centimeters deep, and 1 x 3 centimeters in area).

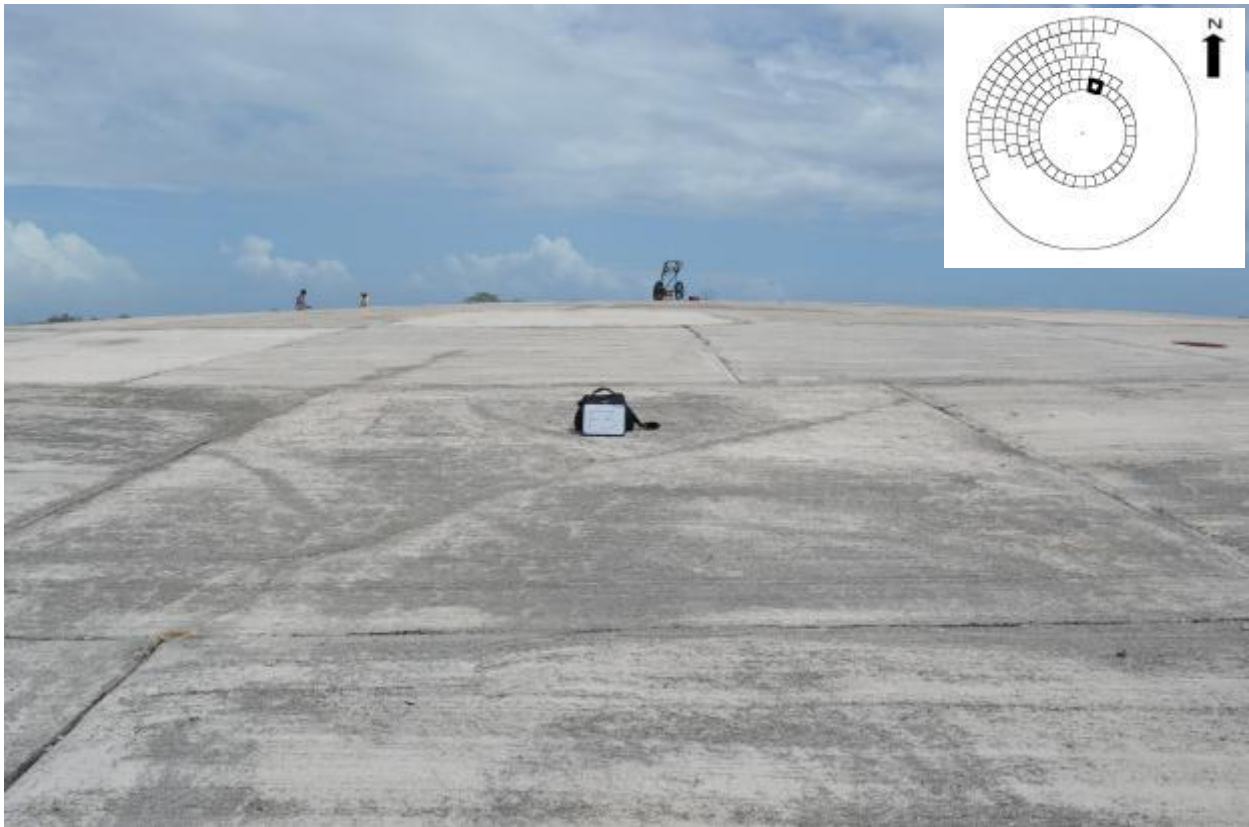
A crack readily identified traversing up from the bottom seam from a point adjacent to the corner intersection of the E4/E5 panels on the ring row below, and traveling across the middle of the panel towards the upper right-hand corner with a fork out to the left-hand side of the panel.

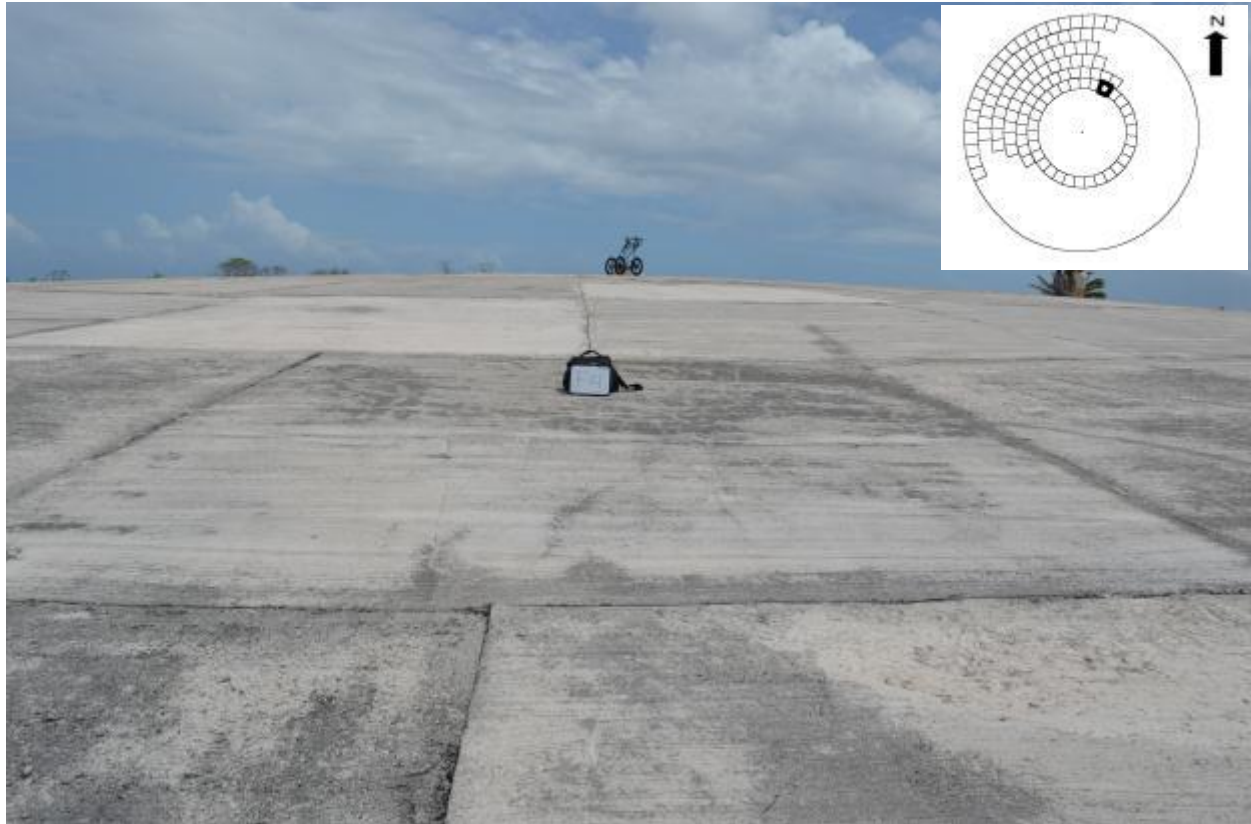
CAP SECTION LOCATION: Panel F4

A surface crack is visible traversing up from the bottom seam from a point adjacent to the corner intersection of the E5/E6 panels on the ring rows below. Some spalling/chipping of concrete observed in the upper left-hand corner of the panel.

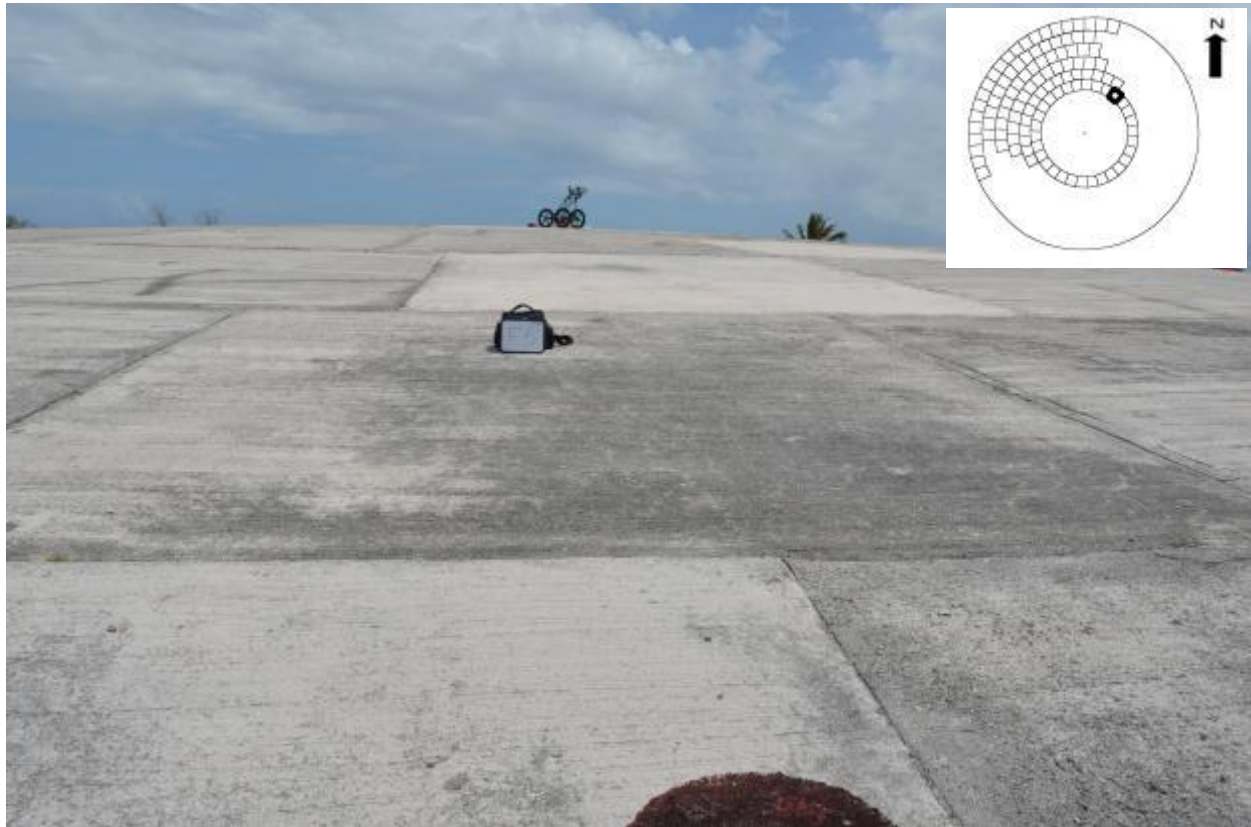
CAP SECTION LOCATION: Panel F5

No significant or obvious interior cracks or spall elements identified but there does appear to be a little more separation along the seams with the adjoining panels, especially in the upper right corner of the panel. In this instance, the edge of the panel is overhanging the bottom of panel G5 on the ring row above.

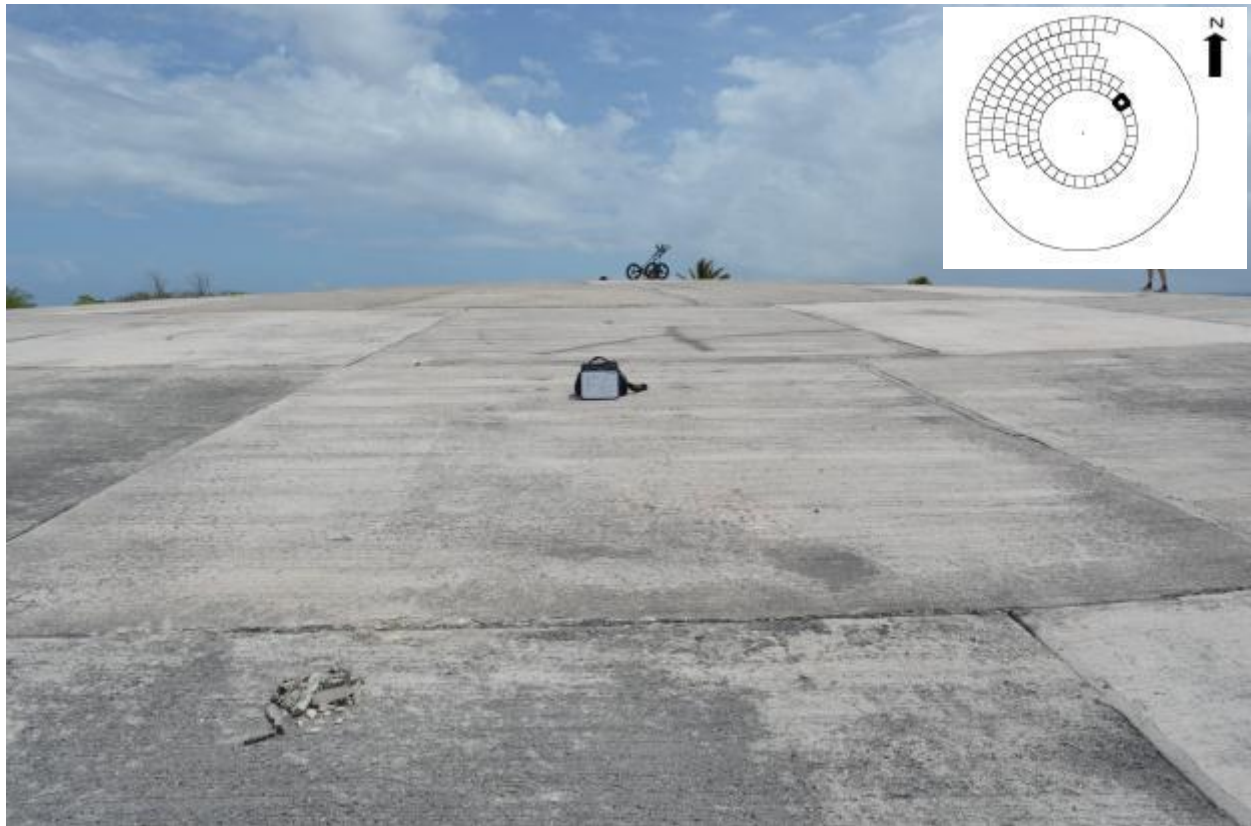
CAP SECTION LOCATION: Panel F6

No significant or obvious interior cracks or spall elements identified. Some spalling/cracking of concrete in the upper left-hand corner and along the bottom seam of the panel.

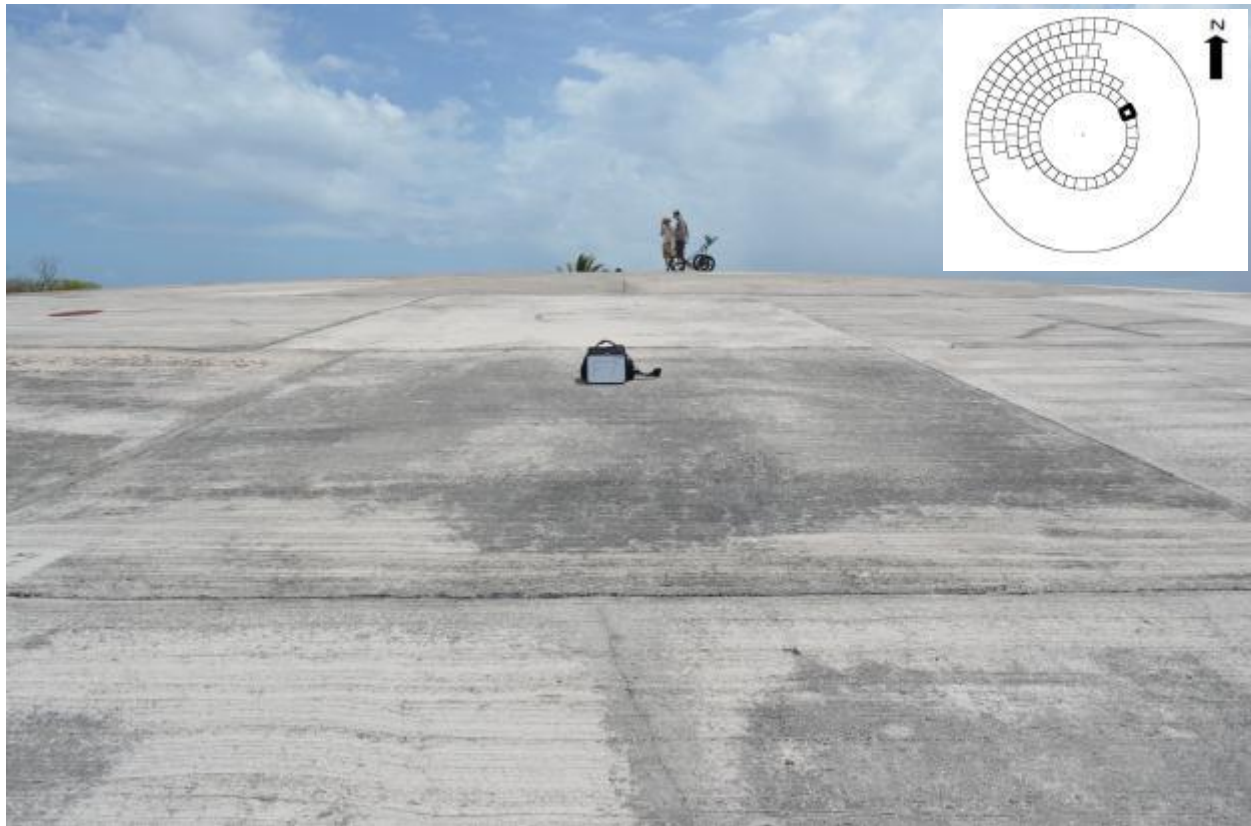
CAP SECTION LOCATION: Panel F7

No significant or obvious interior cracks or spall elements identified.

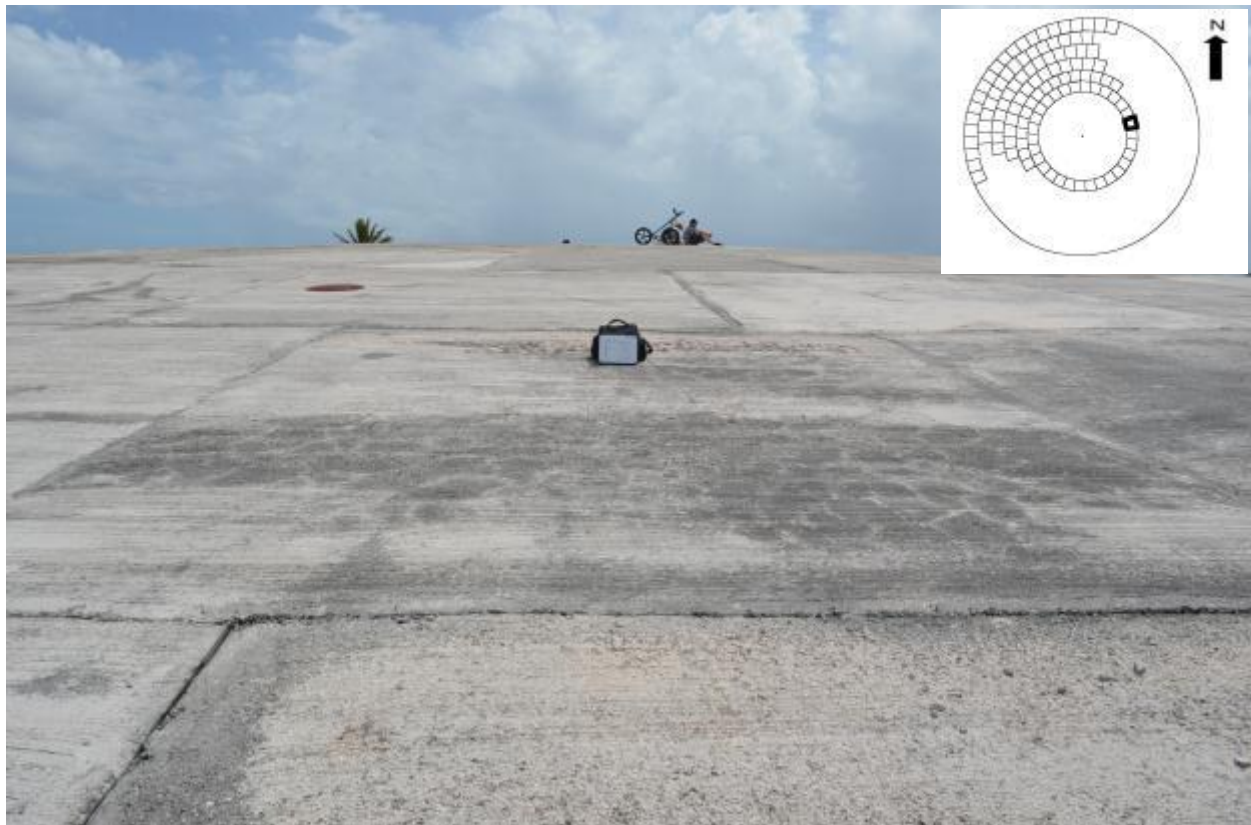
CAP SECTION LOCATION: Panel F8

The panel has a slightly weathered appearance across the bottom of the segment. No significant or obvious interior cracks or spall elements identified. Some minor spalling/cracking of concrete along the upper seam of the panel.
